## **Minerals Inspection Report**

Mine Name: PR Spring Mine	Permit Number:	M/47/0090	Mine Status:	Active
Operator Name: US Oil Sands	Inspection Date:	8/19/2015	Permit Fees:	Paid
Inspector(s): A. Abate, M. Tenney	Inspection Time:	10 AM	Bond Amount:	\$376,000
Attendee(s): David Hansen, Consultant, D. Thornton,	+ Weather:	Sunny 70s	Bond Escalation:	6/13/2019
Inspection Purpose: Determine sampling locations for water monitoring program			Prior Inspection:	08/05/2014

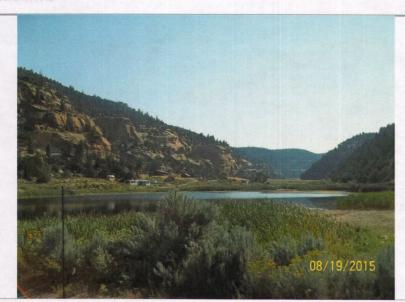
The first stop was to examine the reservoir at the Delambert Ranch. Reservoir water is collected behind a large earthen dam. Water in the reservoir appears to be fed primarily by an alluvial system at the canyon bottom that collects precipitation. Vegetation observed in the canyon bottom was mostly wetted meadow grasses. Two springs were identified in the area of Delambert's ranch. These springs both outcrop on the northeast slope of the south side of Main Canyon and daylighted at the same elevation. The springs appear to contribute some water to the alluvial valley, but they are not what appear to be the primary source of water. The Delambert spring MC-C was observed to be flowing at approximately 8-9 gallons per minute. One was previously unidentified (noted as DEL1) as a GPS point. This spring was flowing at approximately 5 gallons per minute.

View of the reservoir at Delambert Ranch looking east.

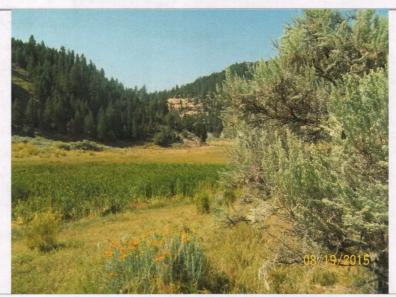
An example of the meadow vegetation found in the canyon bottom of Delambert Ranch.

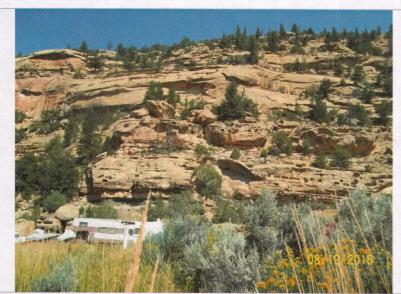
The ranch sits at the base of the canyon. These sandstone outcrops make up the Wasatch formation.

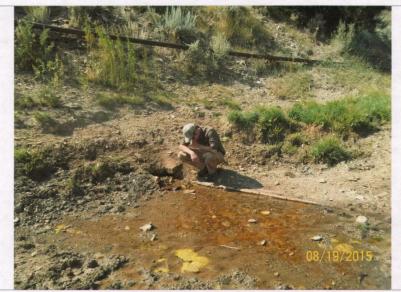
The previously unidentified spring DEL1, located on the southern side of Main Canyon and originating from bedrock on the north-facing slope.

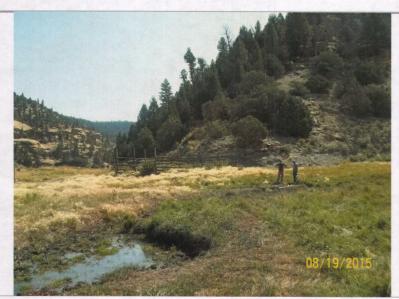
The enclosed area is the Delambert C Spring. Flow was estimated to be 8-9 gallons per minute.

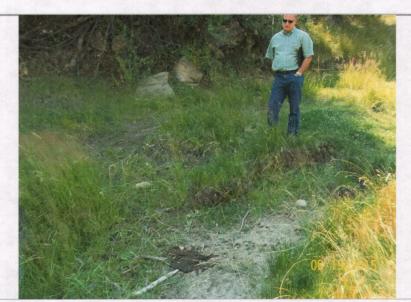
Visited Spring MC-B which was dry at the time of the visit but has reported to flow only occasionally. Mr. Delambert claimed that this spring dried up in the recent past.

Spring MC-B not flowing at the time of the site visit.

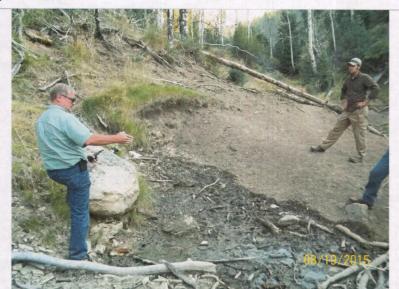
Visited the spring locations in Long Shot Canyon. These springs were flowing. Similar to DEL1 and MC-C, these springs outcrop on the northeast slope of the south side of Main Canyon. All springs identified during this visit originated in bedrock.

Springs identified in Long Shot canyon were seeping at approximately 1 gallon per minute.

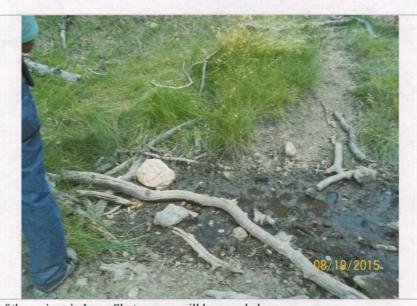
One of the springs in Long Shot canyon will be sampled.
